**Bunker Hill Mine Flood-Stanly
Ore Body In-Mine
Reconnaissance Report**

**Bunker Hill Mine Water
Presumptive Remedy**

Prepared for
**U.S. Environmental Protection Agency
Region 10**

Bunker Hill Mine Flood-Stanly Ore Body In-Mine Reconnaissance Report (Supplement 2 to the Presumptive Remedy Conceptual Model)

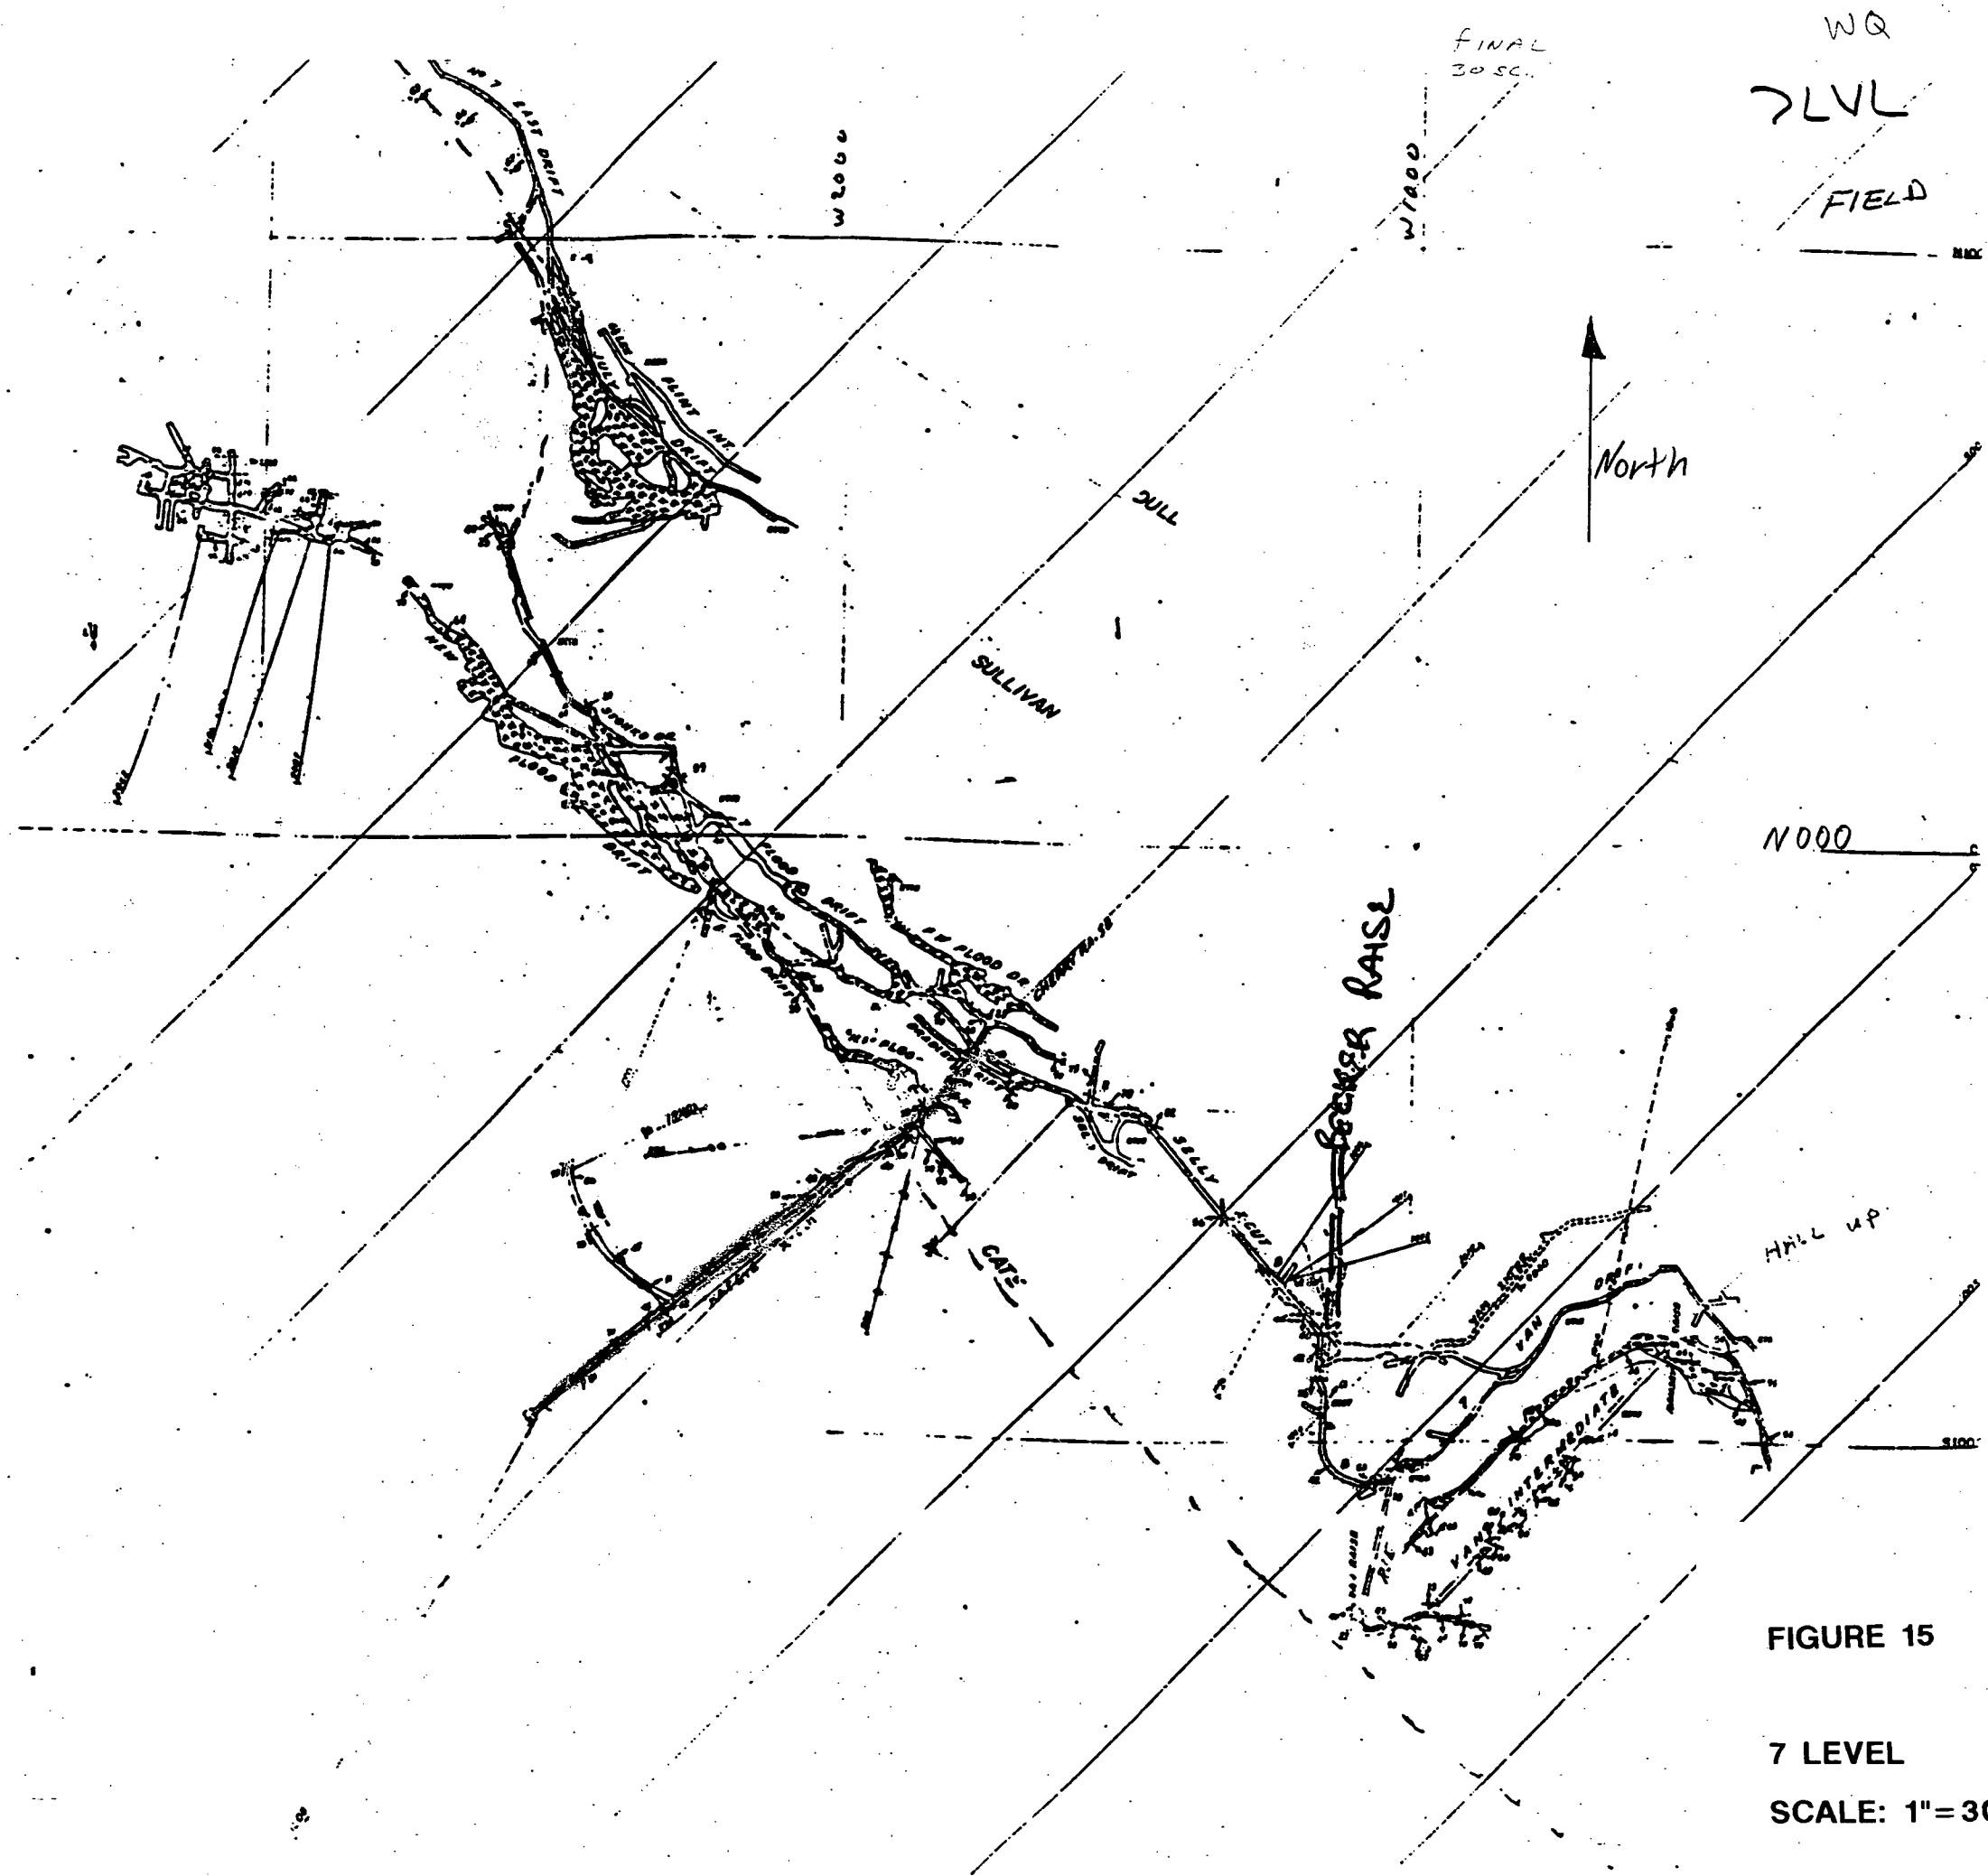
FIGURE 15

Access to 7 Level is largely blocked. A well constructed bulkhead blocks access to, and discharge from, the Flood-Stanly workings. The bulkhead probably is blocking discharge from Flood-Stanly workings and diverting it down to 8 Level via transfers or other manmade structures. The main drift in the opposite direction is also blocked.

Approximately 20 gpm of relatively good quality water discharges from the lacing just before the bulkhead (EC 1640 $\mu\text{S}/\text{cm}$). That water drains down the Cherry Raise.

The most significant flow on 7 Level comes from a single diamond drill hole at the end of the Kateye drift, straight ahead off the Cherry Raise. The water is of relatively excellent quality, with a historical EC of approximately 100 $\mu\text{S}/\text{cm}$. The typical discharge rate is approximately 100 gpm, with seasonal increases that occur mid to late summer. This water drains toward the Cherry Raise, to an ore transfer raise that discharges on 9 Level, approximately 50 feet from the bottom of the Cherry Raise.

A special case of drill hole plugging is the high capacity (high pressure?) drill hole on 7 Level. That hole discharges more than 100 gpm of relatively excellent quality water. This discharge contributes to the hydraulic load at the treatment plant. Another serious consequence of this discharge is its impact on ditch and track maintenance underground.

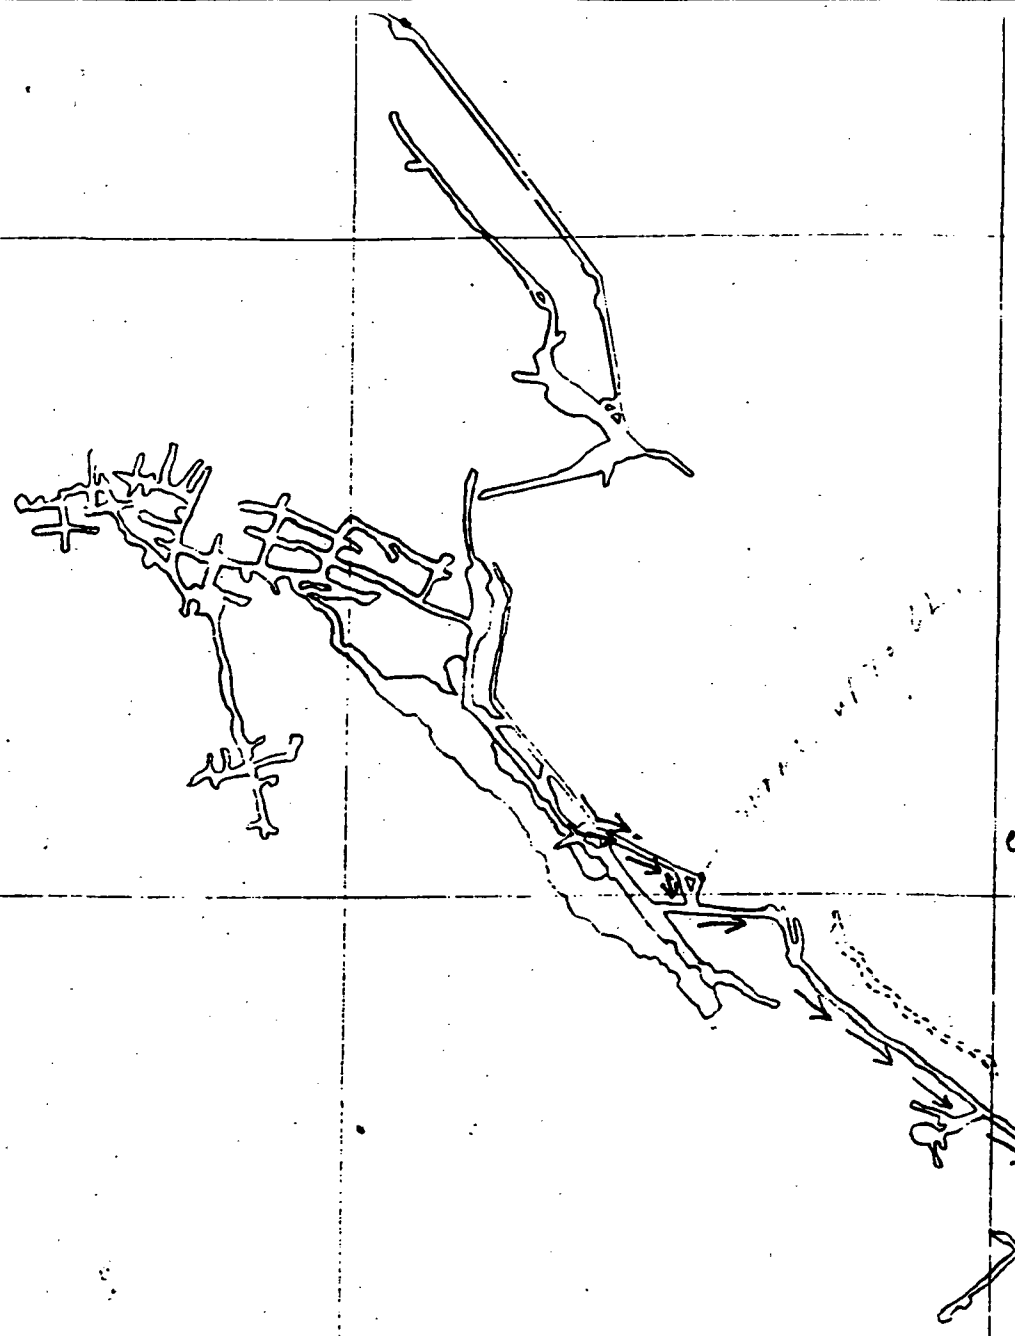
FIGURE 18

Eight Level provides good access to the Flood-Stanly workings. Flow was low in mid-June when the reconnaissance of this level was conducted, and it appeared that peak flow had already occurred. However, it appeared that major discharges onto 8 Level from transfers and raises from 7 and/or 6 Levels had occurred in the recent past. The majority of 8 Level water flows into transfers, stopes, and other manmade openings, and is very likely the flow path for major discharge to the Stanly Crosscut on 9 Level.

The major flows appear to have washed significant quantities of muck out of the ore chutes onto 8 Level, and deposited the material onto the tracks and into the ditches. This appears to have diverted more water toward the Cherry Raise than had flowed that direction previously (mid-1980's). This is probably partially responsible for the increased flow down the Cherry Raise, as compared to historical data.

Relative water quality was fair to poor. EC ranged from 3,500 to 15,500 $\mu\text{S}/\text{cm}$. The flow with the highest EC (poorest quality) was that which discharges directly to the Cherry Raise.

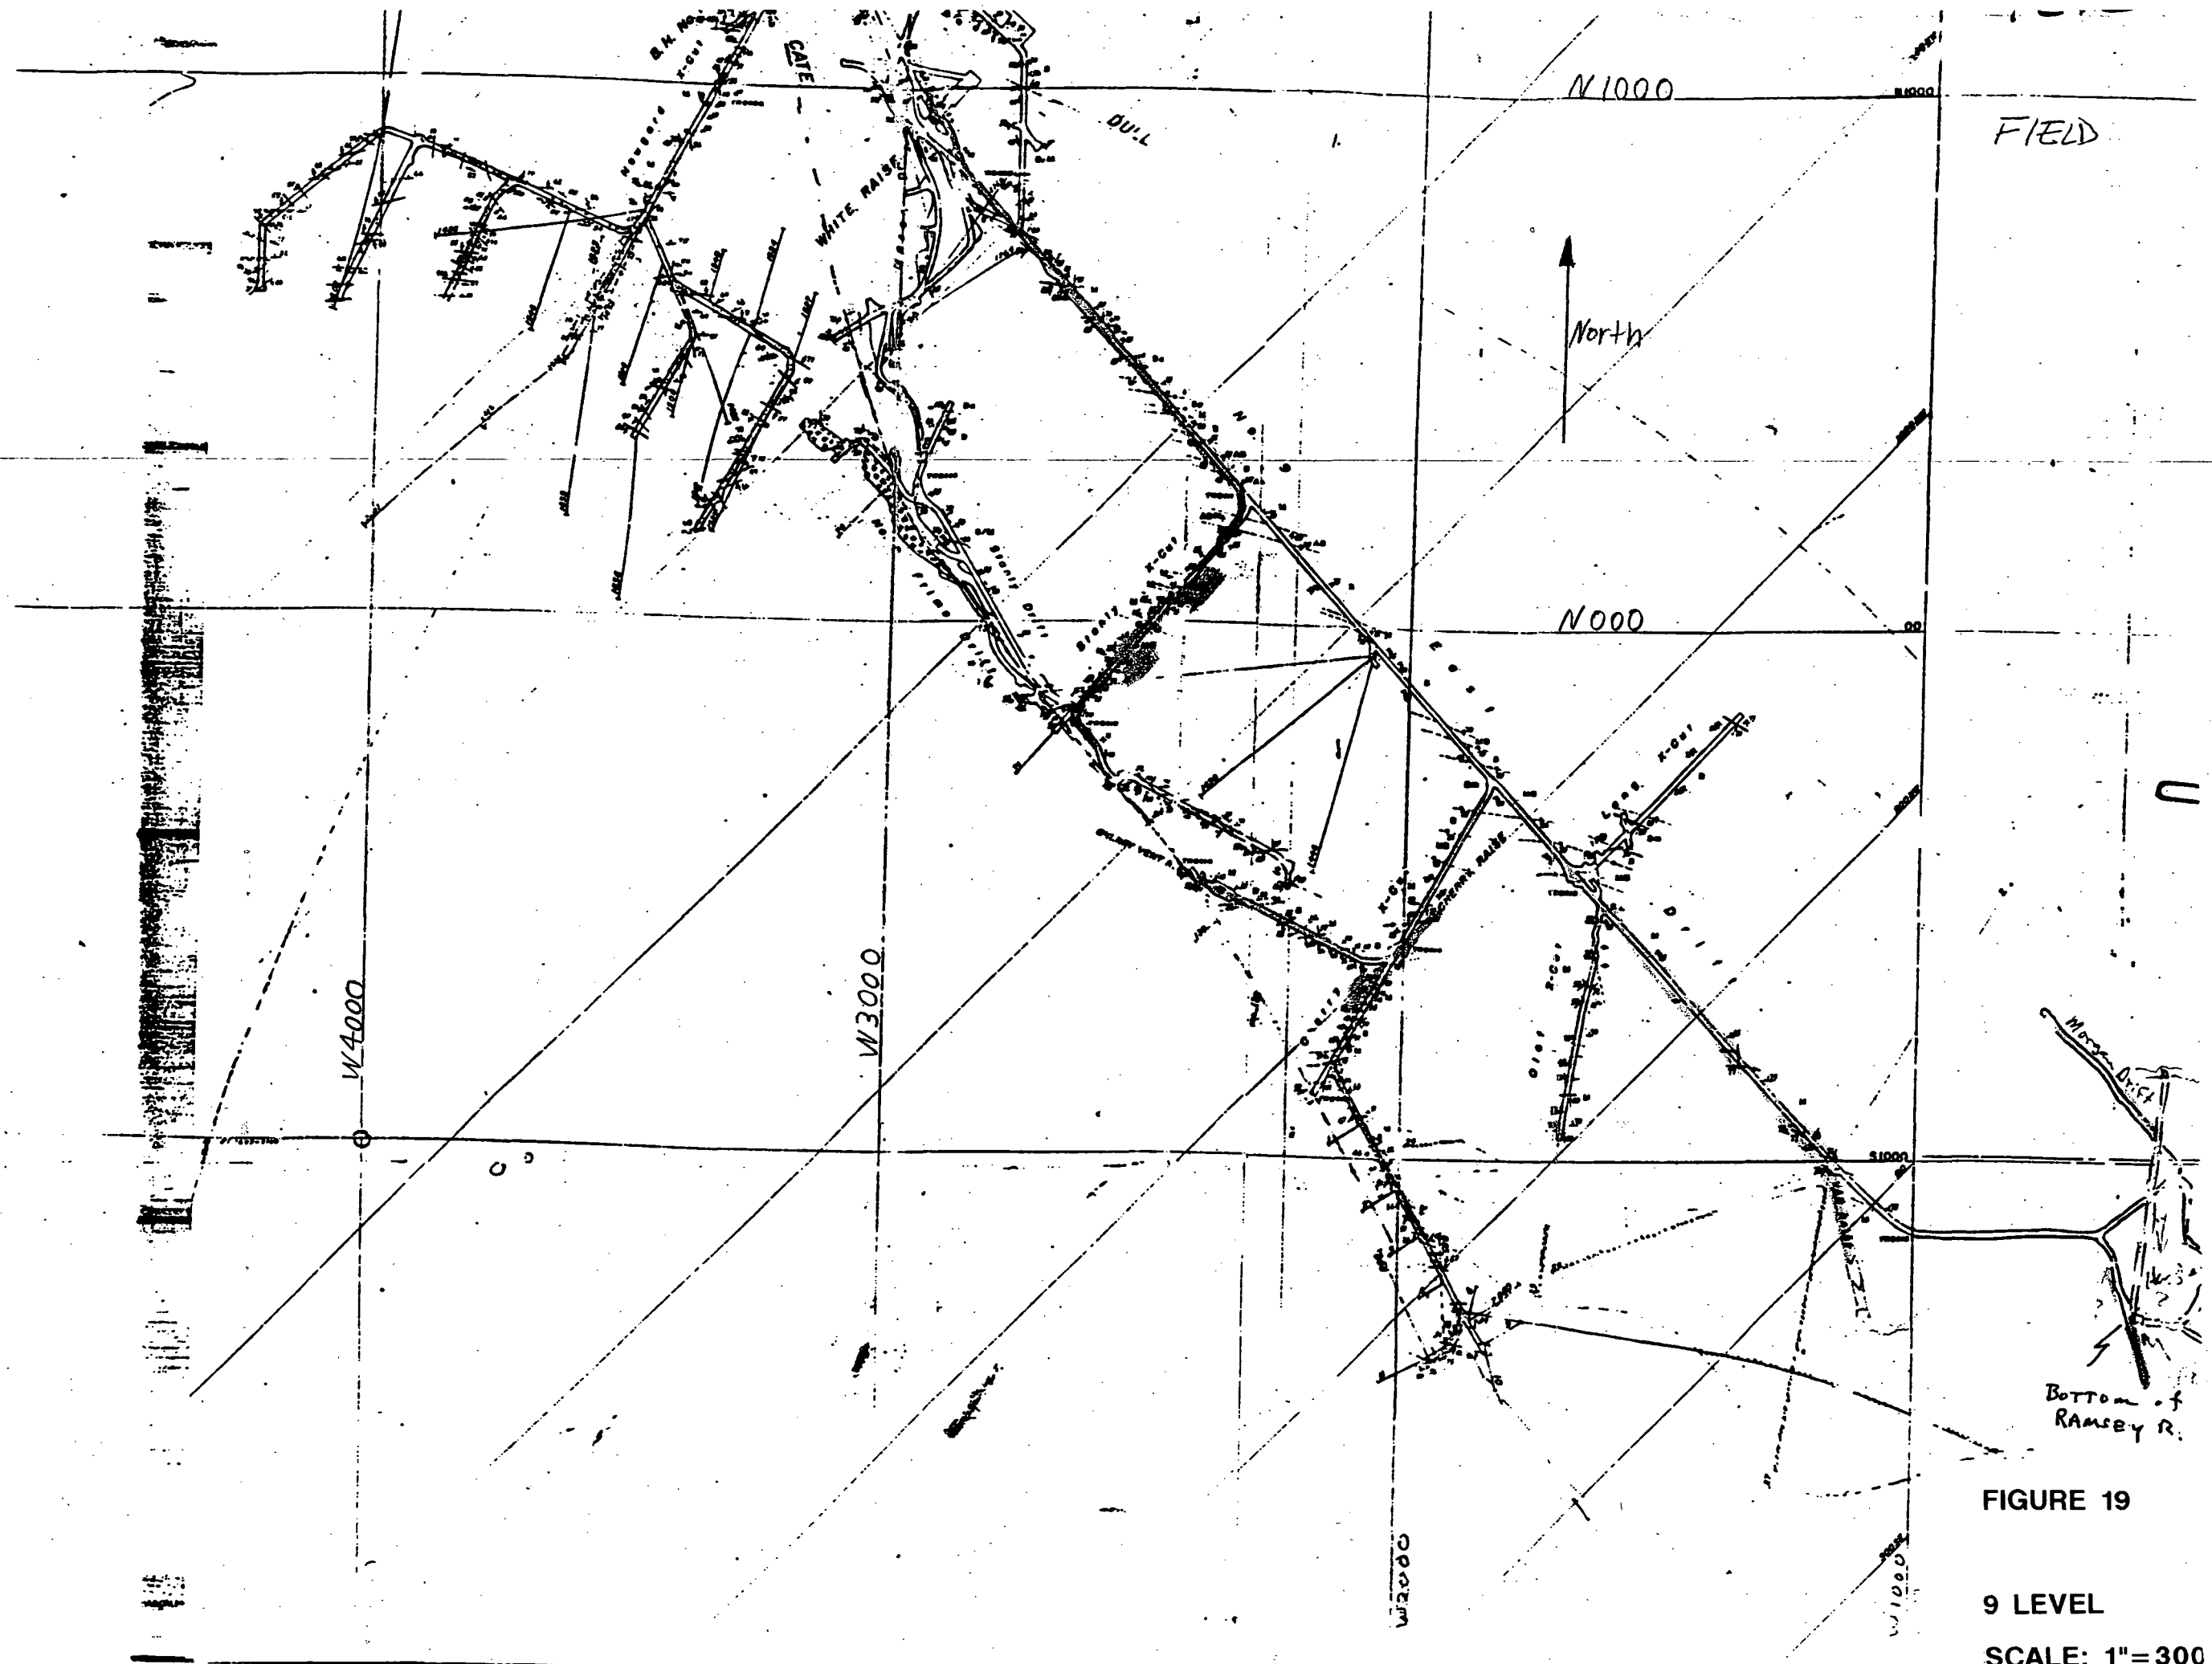
FIGURE 19

Discharge from the Flood-Stanly workings to 9 Level is mainly to ore transfers that discharge into the Stanly Crosscut, and to the Cherry Raise. These locations are monitored at 9SX, 9SO and 9CR. Some discharge from the shallow Flood-Stanly workings flows via a circuitous path to the Van Raise. This flow is monitored at 9VR.

Water quality at 9SX, 9SO, and 9CR is consistently poor. EC varies from 5,000 to 19,000 $\mu\text{S}/\text{cm}$. Water quality at 9VR is generally fair, with EC readings between 1,000 and 2,000 $\mu\text{S}/\text{cm}$.

The timing of peak flow on 9 Level indicates that high elevation snow melt controls this flow path. Surface runoff and infiltration peaked in the West Fork of Milo Creek at the same time that peak discharge occurred in these 9 Level locations. This suggests that the likely mechanism is snowmelt that recharges the hanging wall of the Guy Caving area. Additional investigation would be required to confirm this hypothesis.
